Characterization of Fatigue Damage for Bonded Composite Skin/Stringer Configurations

NASA/TM-2008-215308

The fatigue damage was characterized in specimens which consisted of a tapered composite flange, representing a stringer or frame, bonded onto a composite skin. Quasi-static tension tests were performed first to determine the failure load. Subsequently, tension fatigue tests were performed at 40%, 50%, 60% and 70% of the failure load to evaluate the debonding mechanisms between the skin and the bonded stringer. For four specimens, the cycling loading was stopped at intervals and the specimens were taken out of the grips. Photographs of the polished specimen edges were taken under a light microscope to document the occurrence and growth of matrix crack and delaminations. At two diagonally opposite corners of the flange, a delamination appeared to initiate at the flange tip from a matrix crack in the top 45° skin ply and propagated at the top 45°/-45° skin ply interface. At the other two diagonally opposite corners, a delamination running in the bondline initiated from a matrix crack in the adhesive pocket. Dye penetrant X-ray radiography was also used to measure the amount of d

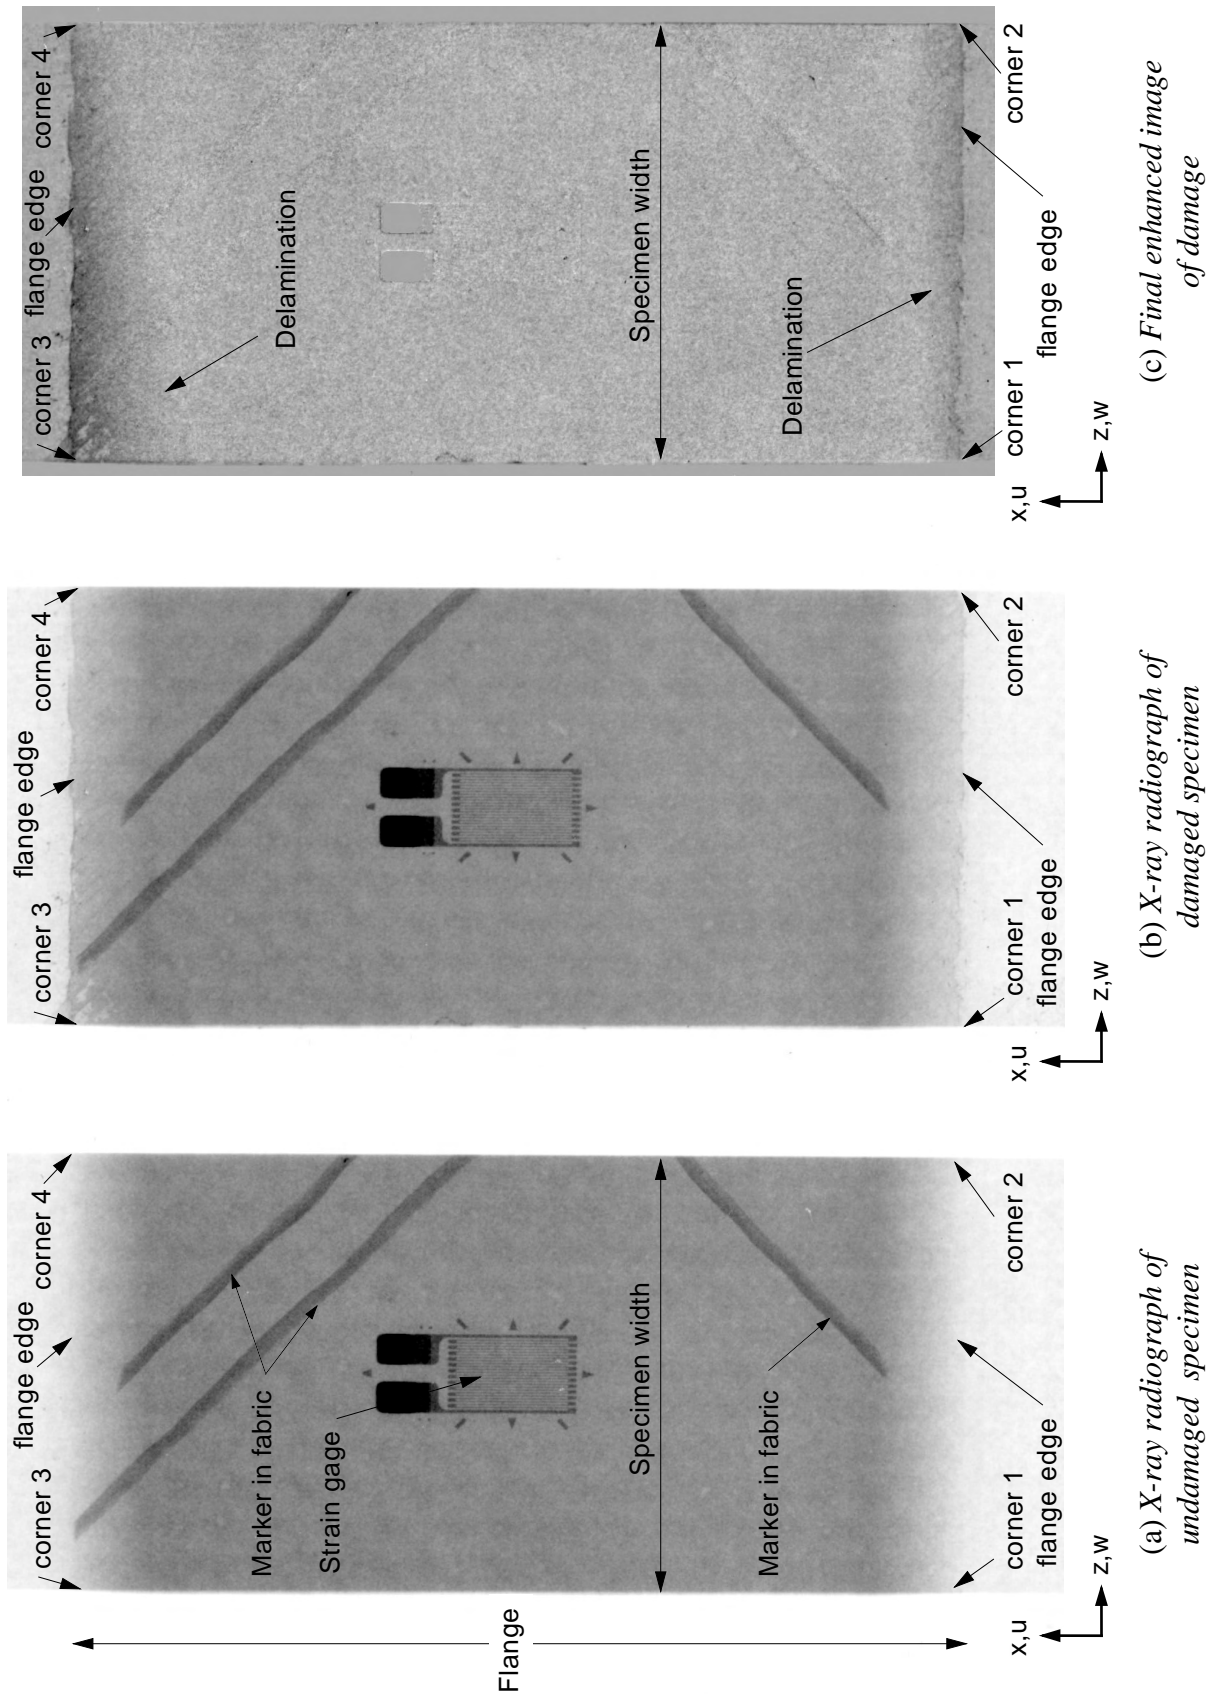
Figure 5. Image processing of X-ray radiographs (specimen 8B-06 after 730 cycles).

(a) X-ray radiograph of undamaged specimen

(b) X-ray radiograph of damaged specimen

(c) Final enhanced image of damage

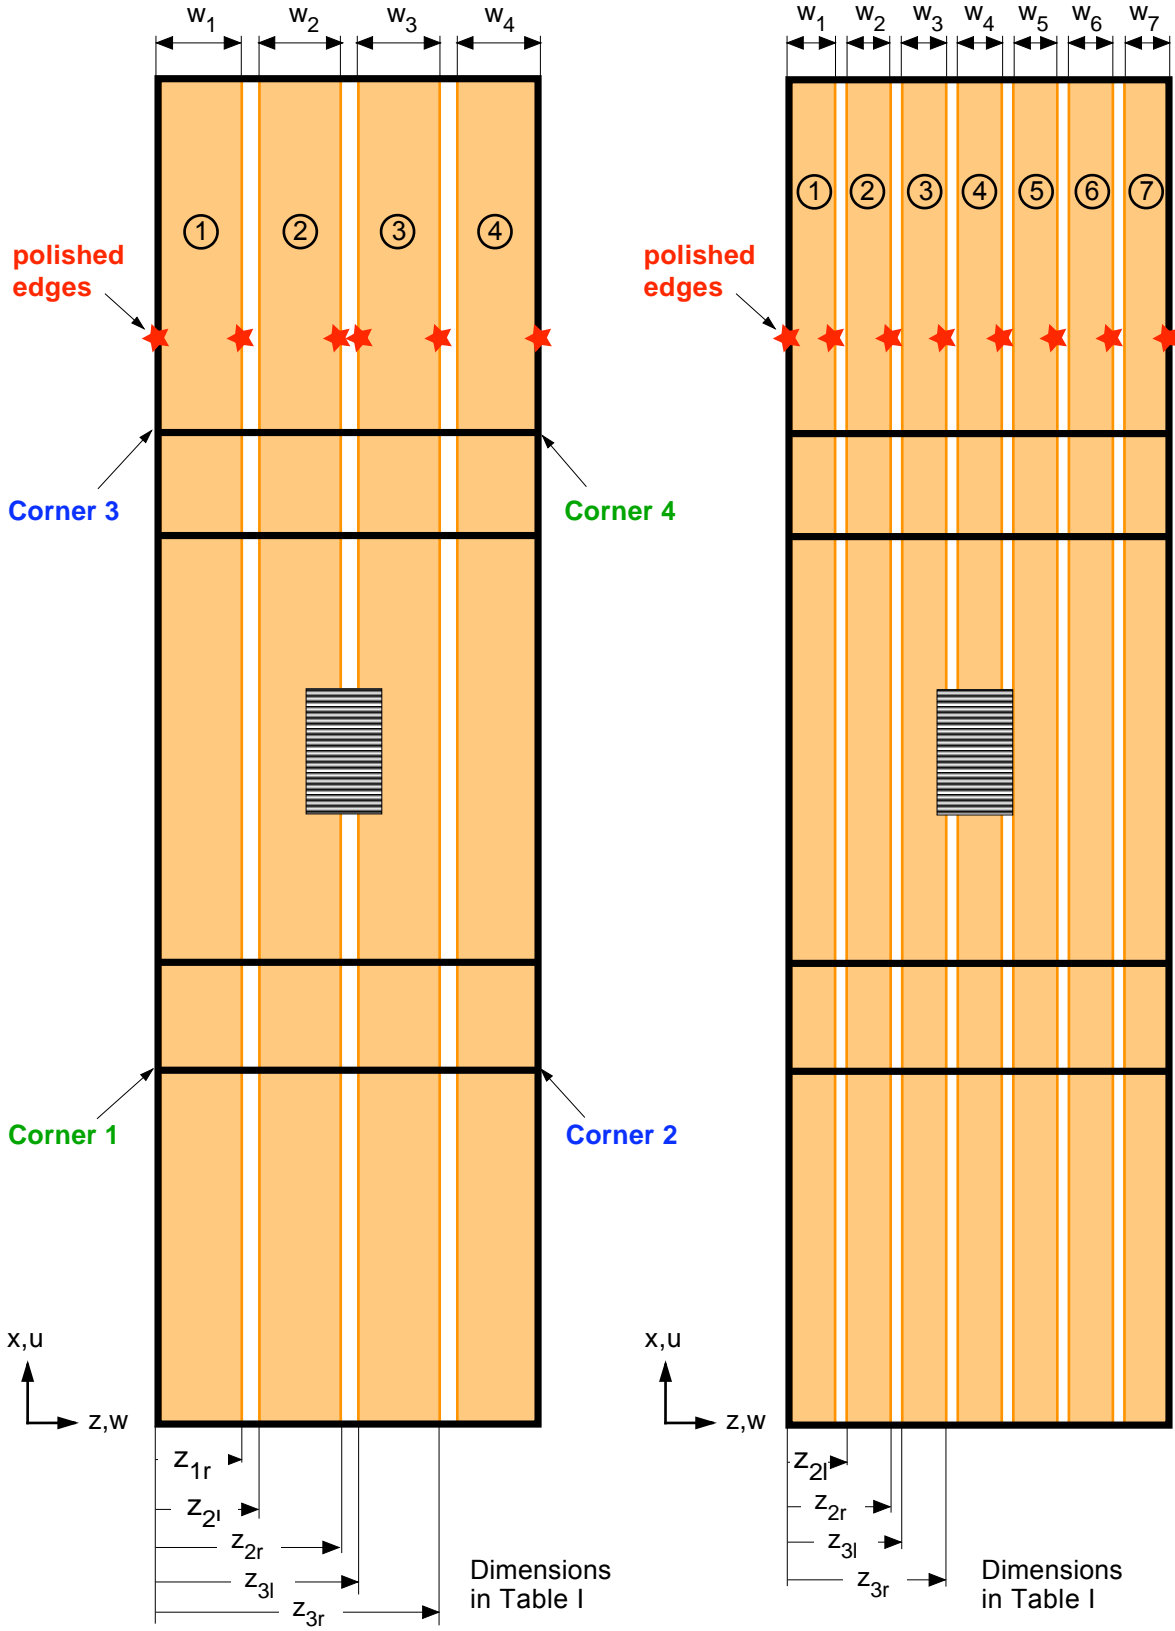
Figure 6. Cutting of specimens.

Finally, two specimens (8B-06 and 10B-03) were cut longitudinally in several slices as shown in the drawings of Figure 6 and the photographs in Figure 7. The thicknesses w_i of the i slices as well as the distance z_{ir} and z_{il} to the right and left edges of the slices (measured from the left edge of the specimen) are documented in Table I. The edges of each slice were polished (marked with a red star) and photographed under a light microscope, as described before. The measurement of the delamination length was combined with information about the location of the delamination through the thickness to obtain a 3-D mapping of the damage as discussed later.

Two specimens (8B-06 and 10B-03) were cut into slices as discussed earlier. The slices are shown in Figures 6 and 7. The edges marked with a red star in Figure 6 were polished and micrographs were obtained to reveal the growth in the interior of the specimen. The micrographs taken across the width of specimen 8B-06 along the flange edge from corners 3 to 4 were assembled as shown in Figure 20. A detail of an x-ray radiograph (taken from Figure 16c) and a sketch of the slices (taken from Figure 6a) were included to help identify the location of the micrographs with respect to the specimen width. At the specimen edges (corners 3, $z_{11}=0.0$ mm and 4, $z_{4r}=25.578$ mm), only one delamination type (B, in red or A1, in light blue) was observed as discussed earlier and shown in Figures 14 and 15. Based on the observations at the edges of the specimen, a simple transition from delamination type B to type A1 was expected to occur in the interior of the specimen. The micrographs, however, reveal a more complex pattern where both delaminations (B and A1) are present simultaneously across most of the width of the specimen. The mechanics of the failure are discussed below. The delamination lengths were measured using image analysis of the scanned and stitched micrographs. The delamination lengths are listed in Table IV. The delamination outline seen in the X-ray image (dark area) captured the size of the delamination well, which is shown by adding delamination lengths (B, in red or A1, in light blue) measured from the micrographs. The images obtained from X-ray radiography, however, were not able to reveal the complexity of the damage pattern observed. An ultrasound inspection, which includes a D-scan, time-of-flight scan or depth scan may be required to identify the complete pattern.

(a) Specimen 8B-06

(b) Specimen 10B-03

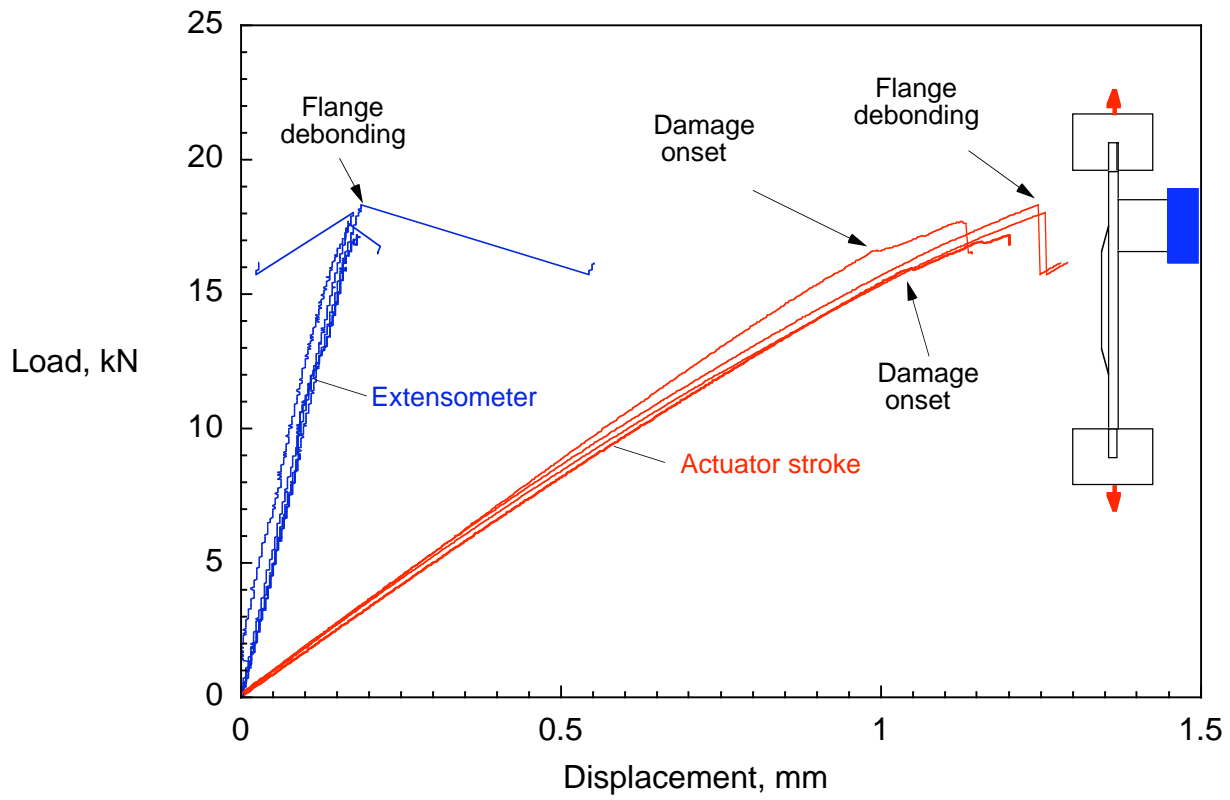
Figure 8. Load-displacement plots for quasi-static tension tests [7].

The load-displacement curves were slightly nonlinear over a wide range as shown in Figure 8. Possible damage initiation was assumed when a small initial load drop was observed prior to flange debonding. At this point, a crack in one flange tip or a small delamination along one flange corner was observed. In two specimens (2B02 and 6B06), no initial load drop or visible damage could be detected. In general, the initial load drop occurred above 90% of the maximum sustained load. The nonlinear strain-load response up to flange debonding is shown in Figure 9. Initially, flange strains dropped before rising again with increasing load. The initial compression phase captured by the strain gage is caused by secondary bending due to the load eccentricity in the flange region and the asymmetric layup with respect to the neutral axis. In all specimens, a load drop was also accompanied by a decrease in strain. The same three specimens that showed a load drop in the load-displacement plots also displayed a drop in flange strain prior to flange debonding. Skin strains were nearly linear until flange debonding occurred, as shown in Figure 9. The value of the damage onset load was averaged from five tests and determined to be 17.8 kN which was later designated as $P_{100\%}$.

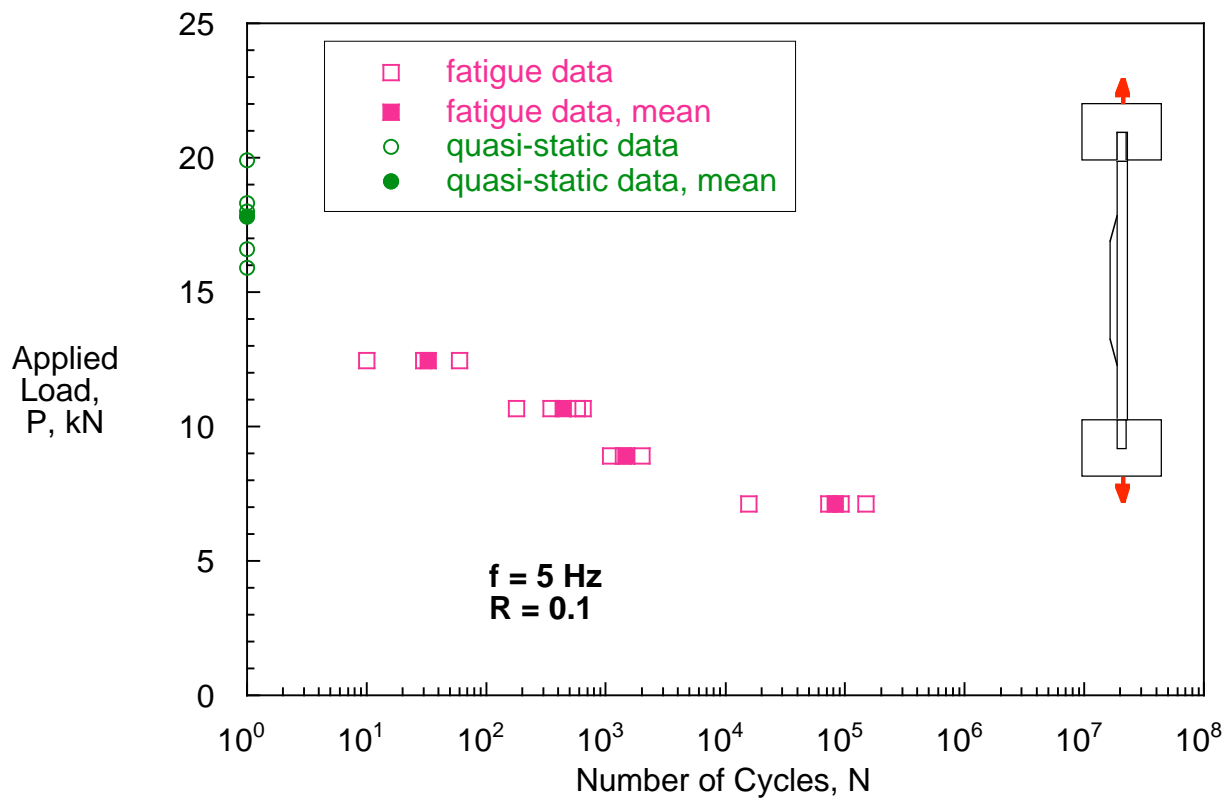
Figure 10. Matrix crack onset fatigue life for composite skin/flange debonding [7].

The load level as a function of the number of cycles to matrix crack onset is shown in Figure 10 for the specimens made from panels 3 and 6 (red squares). The loads at onset of damage obtained from the quasi-static tests are shown on the ordinate (green circles). These data points represent the damage initiation loads given in Table II. The mean values for each load level are represented by solid symbols. The load level as a function of the number of cycles to delamination onset is shown in Figure 11 for the specimens made from panels 3 and 6 (purple diamonds). The number of cycles to delamination onset is a cumulative number and includes the cycles to matrix crack onset. There is a considerable difference between matrix crack onset and delamination onset, especially when considering the mean values. An almost linear relationship between P_{\max} and $\log N$ can be also observed for delamination onset, with some scatter between the replicates tested at each load levels [7]. The results obtained from specimens made from panel 2 were added to the plots as shown in Figure 12 and 13. The specimens made from panel 2 exhibit a longer life compared to the life of the specimens made from panels 3 and 6. This is to be expected, since the lay-up of panel 2 leads to a stiffer specimen resulting in a lower stress at the flange tip.
